**DEPARTMENT OF TRANSPORTATION**

Contract #: 04-0120F4Cty: SF/ALA Rte: 80 PM: 13.2/13.9File #: 69.28**WELDING INSPECTION REPORT****Resident Engineer:**Siegenthaler, Peter**Address:** 333 Burma Road**City:** Oakland, CA 94607**Report No:** WIR-025261**Date Inspected:** 08-Jul-2011**Project Name:** SAS Superstructure**OSM Arrival Time:** 1500**Prime Contractor:** American Bridge/Fluor Enterprises, a JV**OSM Departure Time:** 300**Contractor:** Zhenhua Port Machinery Company, Ltd (ZPMC), Changxing Island **Location:** Shanghai, China**CWI Name:** See Below**CWI Present:** Yes No**Inspected CWI report:** Yes No N/A**Rod Oven in Use:** Yes No N/A**Electrode to specification:** Yes No N/A**Weld Procedures Followed:** Yes No N/A**Qualified Welders:** Yes No N/A**Verified Joint Fit-up:** Yes No N/A**Approved Drawings:** Yes No N/A**Approved WPS:** Yes No N/A**Delayed / Cancelled:** Yes No N/A**Bridge No:** 34-0006**Component:** OBG**Summary of Items Observed:**

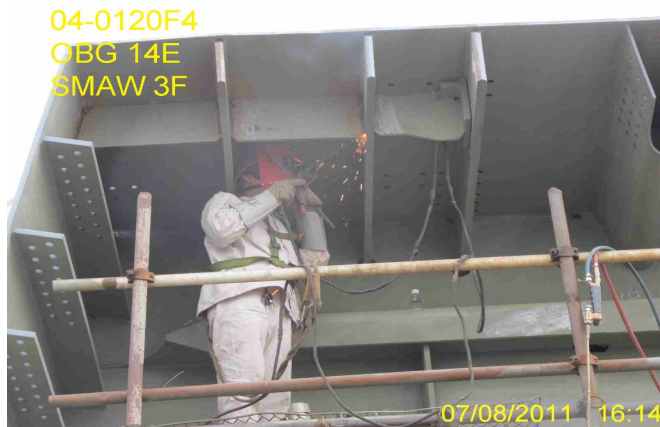
This QA inspector performed a random observation for the OBG. During the observation performed it was noted ZPMC was in process of welding on segment assembly. ZPMC QC inspector Zhu Yuan Yuan was present at this time of this observation and informed this QA inspector of the work that is in process and identified Liu Hua Jie as the CWI. It was stated that ZPMC had 2 welders and identified the welders by ZPMC welder identification number appointed to then by ZPMC. This QA inspector verified this information for the following location;

Weld- SEG3019AE-083, 084, 075, 076

The following digital picture illustrates stiffener plates being welded.

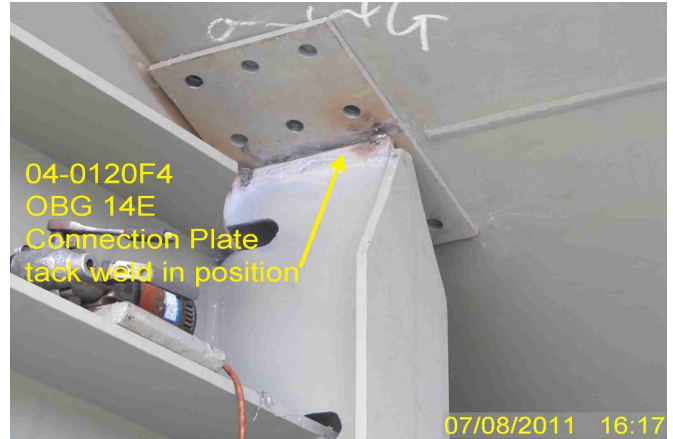
ZPMC performed SMAW welding on 14E FL3 floor beam (PP125/FB3260A), (PP126/FB3265A), PP127/FB3271A), tacking welding connection plate joining floor beam to side plate, welder 050232

The following digital picture illustrates connection plates tack welded in position.
